# Incarnation Lutheran Church

## Congregation Discussion Forum: Roof Project Details

Hosted by the Congregation Council and ILC Facilities Committee  
Thursday, February 27<sup>th</sup> from 6-7 PM via Zoom

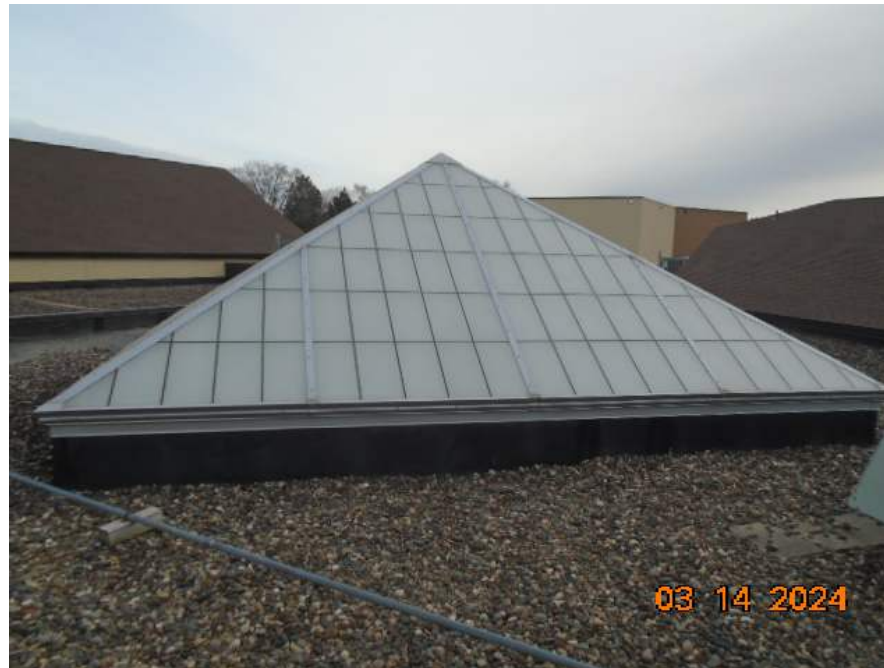
# Skylights

- ▶ The existing skylights will need to be removed at the time of construction to properly install the new roof membrane.
- ▶ At Area A1 there is a large translucent skylight present. The translucent panels were recently refurbished and replaced. We recommend that this translucent skylight be removed and reinstalled with new gaskets on the existing roof curb.

| COST ITEM | COST |
|---|---|
| Translucent Skylight Refurbishing at Area A1 (1 @ \$20,000 ea.) | \$20,000 |

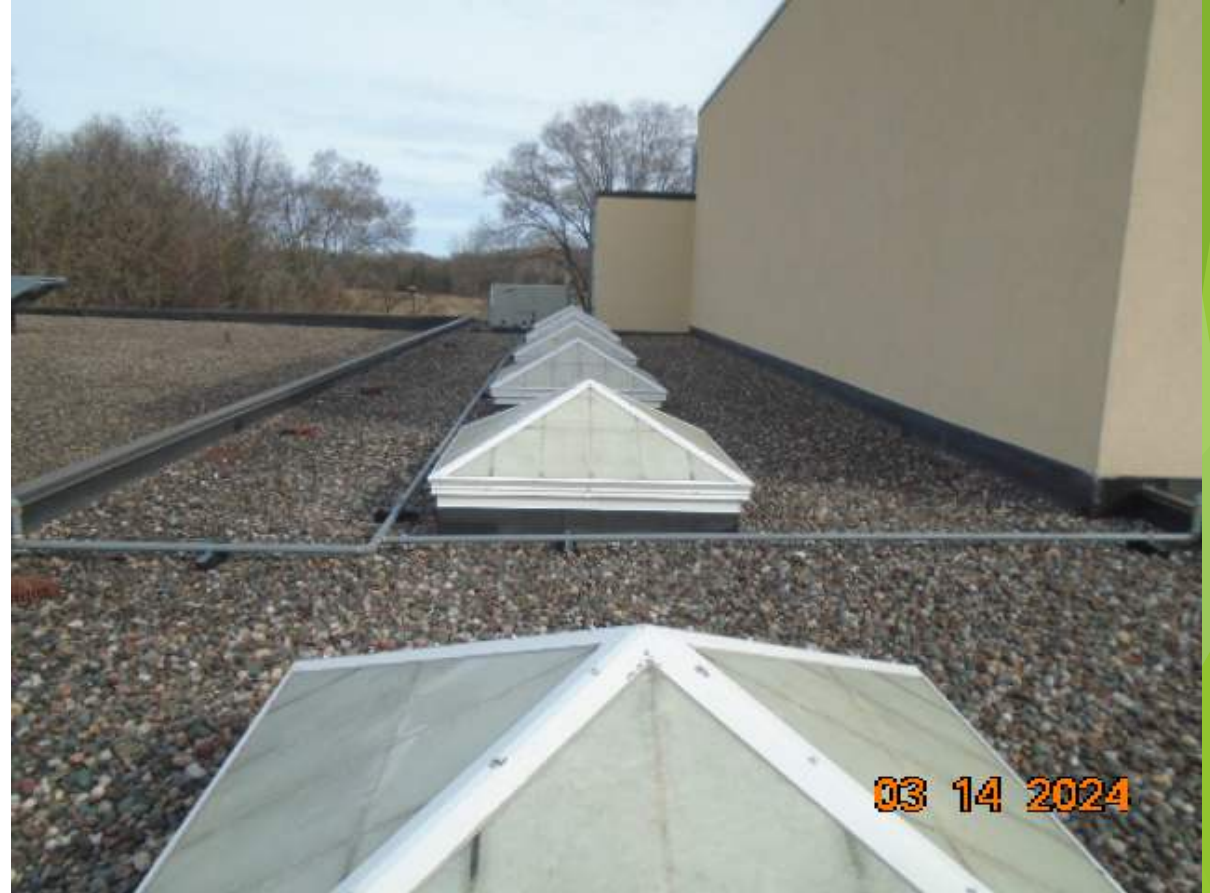
# Skylights

- ▶ At Area B5 (the gathering space outside of Incarnation Hall) there are seven translucent skylights present.
- ▶ The translucent panels are 20 years old and are deteriorated including delaminated face sheets.
- ▶ We recommend that these translucent skylights be replaced with new translucent skylights.

| COST ITEM | COST |
|---|---|
| Translucent Skylight Replacement at Area B1 (7 @ \$10,000 ea) | \$70,000 |

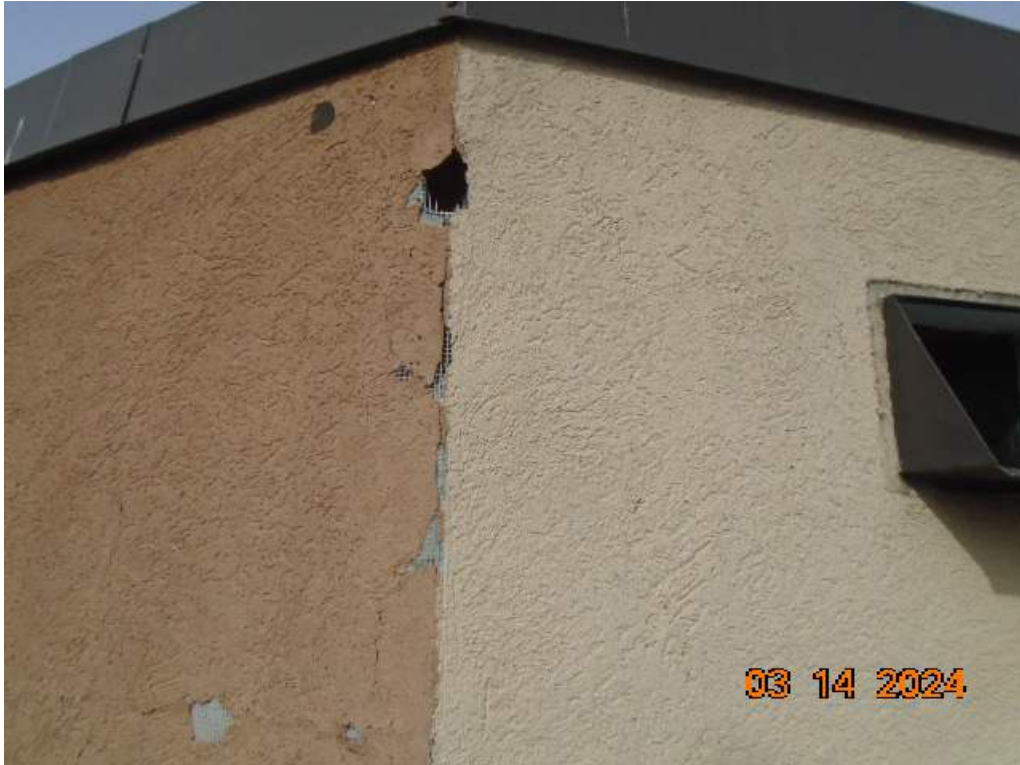
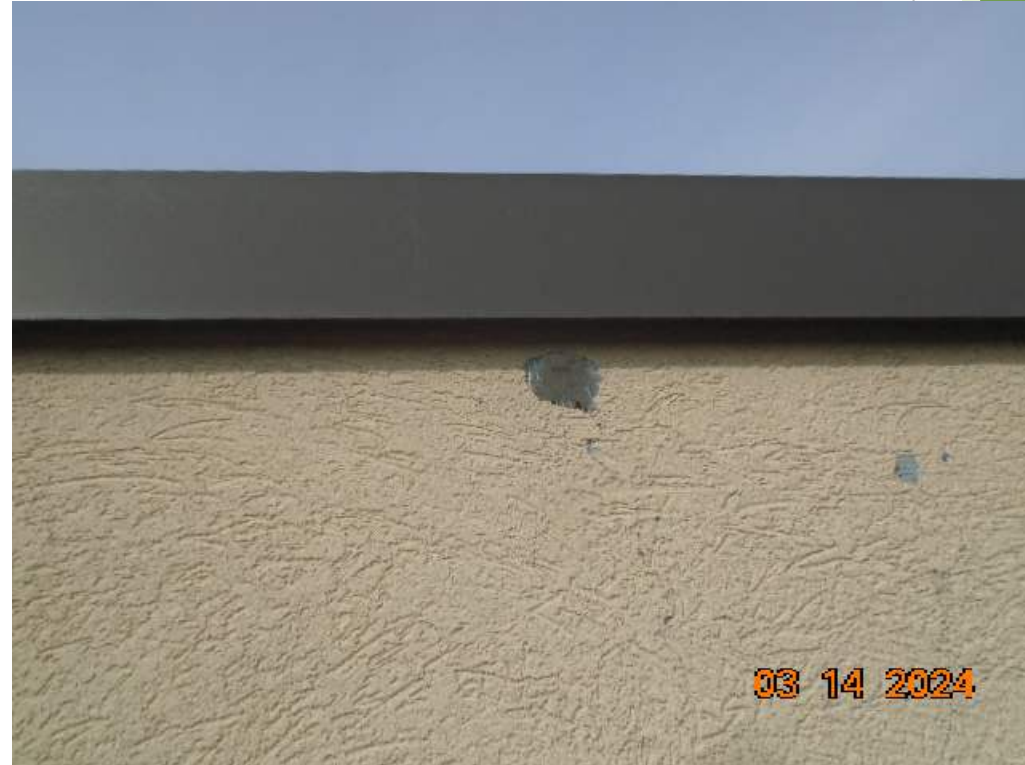
# Damage to EIFS

- ▶ EIFS stands for Exterior Insulation and Finish System. This is a synthetic stucco wall system that was widely used at the time of this addition was constructed.
- ▶ The existing roof membrane extends and is terminated behind this finish system. Portions will need to be removed to properly terminate the new membrane.
- ▶ At the EIFS walls on Areas B1-B5, the EIFS wall finishes are severely deteriorated and need replacement. There are also low base flashing heights present at adjacent roof areas.

- ▶ The existing EIFS wall system will be removed and replaced with a new metal wall panel system
- ▶ This will include the incorporation of a new air/moisture barrier, continuous rigid insulation and sub-framing girt system.
- ▶ This new metal panel wall system will accommodate the new roof insulation heights
- ▶ Will provide a more durable and weather resistant wall system.

| COST ITEM | COST |
|---|---|
| EIFS Wall Replacement with Metal Wall Panel System (5,400 sf x \$150/sf) . | \$810,000 |
